The BrickKicker is pleased to present this professional home inspection report for the property located at:

> 849 N. Ellsworth St Naperville, IL 60563

inspected on 10/16/2015

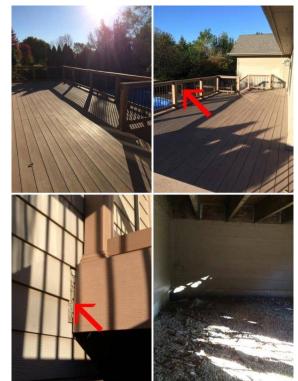
Loose hand railing present on the deck. Properly securing any loose railings is recommended for safety.

The rear deck had an area of loose or exposed flashing where the deck connects to the home. This is above the basement walk out steps and could lead to moisture infiltration to the internal building wrap or framing structure. Properly sealing this area is suggested.

**Open Flashing / Loose Rail**

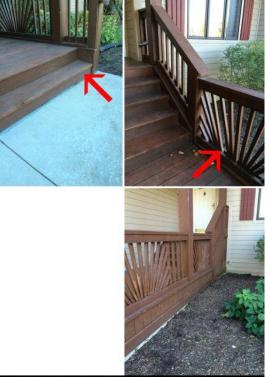
Wood Steps: The handrail for the front entry steps was loose. Properly securing any loose railings is recommended for safety.

Areas of the balusters at the front entry steps were damaged or rotted. Proper repair is recommended.

The first step at the main entry was noted to be loose. Properly securing any loose steps is recommended for safety.

Loose Step / Damage Balusters / Not Viewed

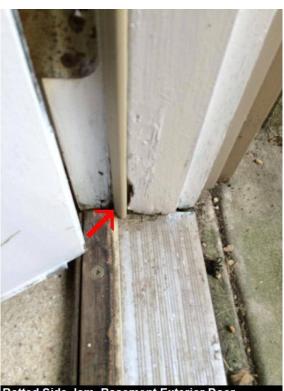
The side jambs at the exterior basement walk out door was rotted. Proper repair and refinishing is recommended.

Rotted Side Jam, Basement Exterior Door

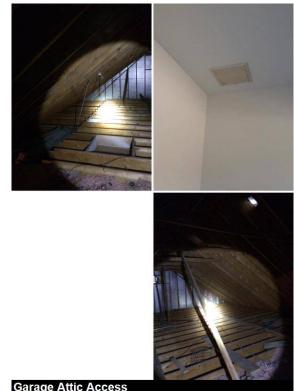
The access to the attic is at least partially from the garage. The access point (scuttle) should be covered with a fireproof material.

Garage Attic Access

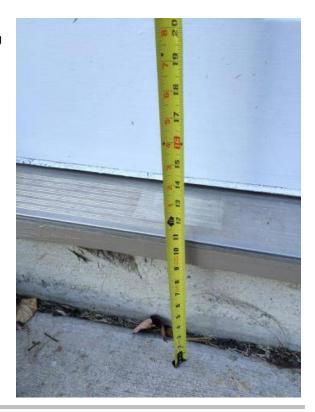
Service Door to Exterior: The stair riser leading from the exterior garage service door appeared to exceed the standard height and may be a tripping hazard. Proper correction is recommended.

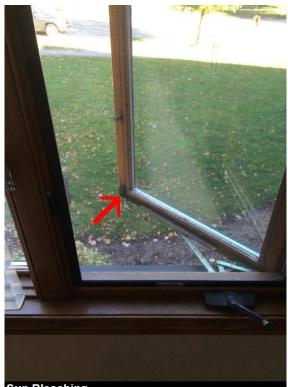
All windows in the home were opened and checked for defects. These windows had signs of sun bleaching which is the discoloration of the stained surface of the window casement. This is mainly cosmetic, however refinishing as desired is recommended.

#### Sun Bleaching

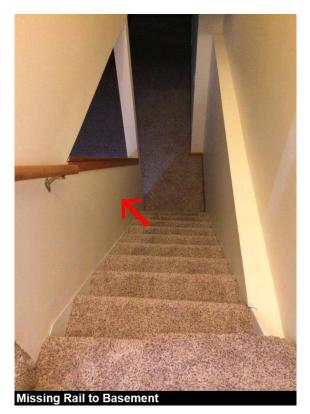
The stairs to the basement did not have proper handrails. This is potentially hazardous and proper installation of handrails at all stairs is recommended for safety.

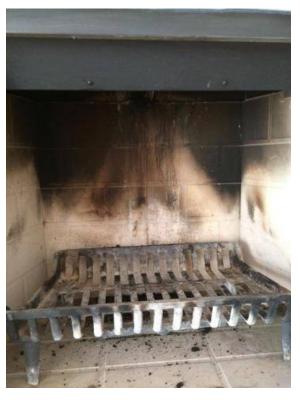
Excessive build-up of soot or creosote was observed in the flue(s) and/or fireplace(s). Creosote is a fire hazard. Cleaning and inspection by a qualified chimney sweep is recommended. Flue or firebox defects may be hidden by soot and creosote.

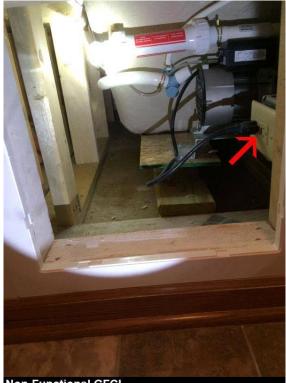
The whirlpool GFCI protection did not operate at the time of the inspection. While the typical repair is to replace the GFCI further review might be necessary to determine the best course of repair.

Loose tile and/or grout was observed in areas around the shower base. Proper repair and re-grouting is recommended to prevent moisture damage

Non-Functional GFCI

Loose Tile

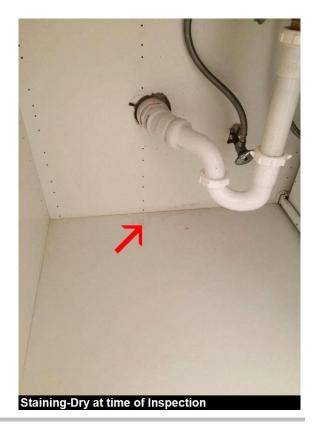
Staining was observed under the sink: The staining was DRY when tested with a moisture meter. Recommend monitoring of the staining and/or checking with the current owner. Also recommend determination and correction of the source of the staining if still active.

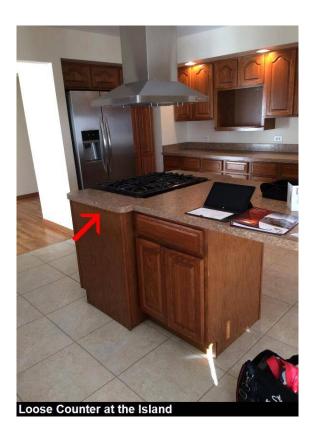
The countertop(s) were loose at the island. Recommend properly securing all countertops to the base cabinets.

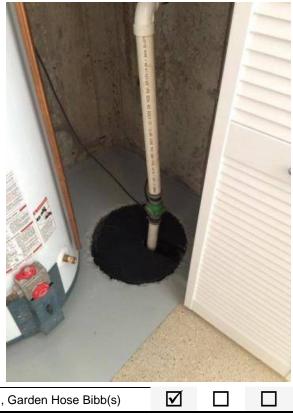
Sump (storm water): Installation of a battery backup system is recommended to assure continued flood protection during a power outage or in the event of the main pump failure.

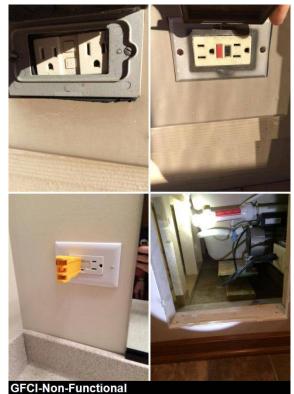
One or more of the Ground Fault Circuit Interrupter (GFCI) outlets did not turn off when the test buttons were operated. These devices reduce the risk of electrocution in wet areas. Recommend replacement of all defective GFCI outlets by a qualified electrician to restore protection. "Defective GFCI Outlet" Location(s): All Exterior, Whirlpool Tub, Hall Bathroom.

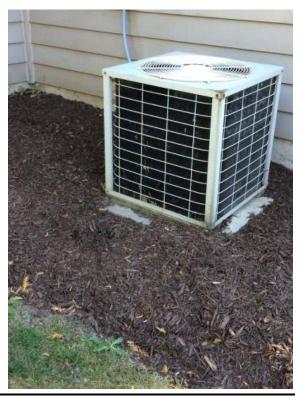
This equipment was near the end of or beyond its normal life expectancy. Budgeting for its eventual replacement is recommended.

The exterior compressor/condenser unit would benefit from professional maintenance. The unit should be kept clean for maximum performance and efficiency. Proper servicing by a qualified heating contractor is recommended.

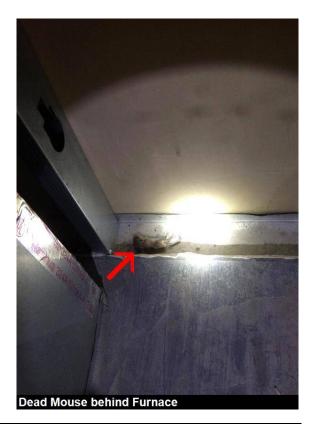
Animal Habitation: One or more dead animals (Mice) was noted in the basement utility room. Proper removal is recommended.

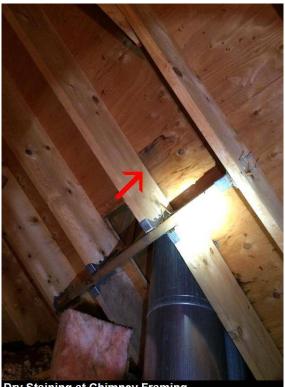
Staining (apparently from moisture) was observed in one or more areas of the attic: The staining appeared to be DRY at one or more areas. Recommend monitoring of the staining and/or checking with the current owner. Also recommend determination and correction of the source of the staining if still active.

Dry Staining at Chimney Framing

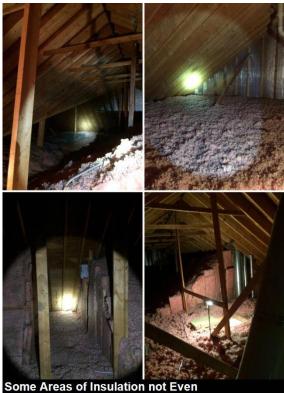
The amount of insulation in the attic space(s) appeared to be adequate but could be better distributed for consistent coverage and improved energy efficiency.
