The BrickKicker is pleased to present this professional home inspection report for the property located at:

> 849 N. Ellsworth St Naperville, IL 60563

inspected on 10/16/2015

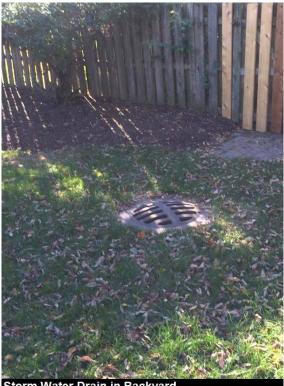
I. Grading and Drainage

Storm Water Drain in Backyard

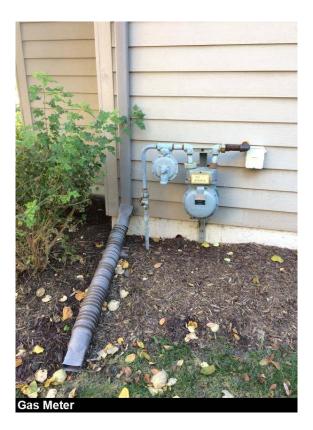
E. Fuel Supply Piping and Storage:

This equipment was near the end of or beyond its normal life expectancy. Budgeting for its eventual replacement is recommended.

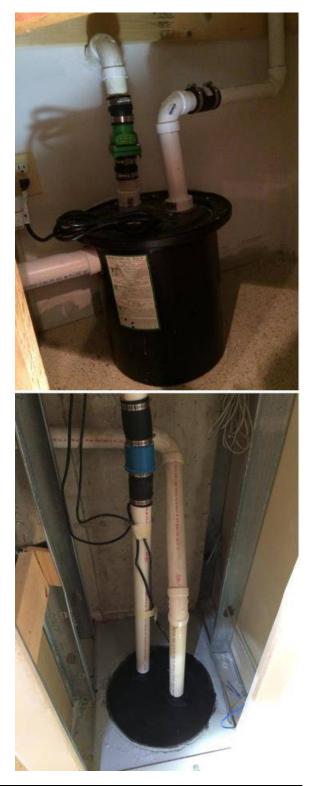
F. Flood Control (storm and sewage pumps)

Ejector (sewage): There are two different types of ejector pumps. One is for the lifting of liquid waste and the other is for solid waste. It is normal to have a liquid waste pump discharge into an inch and a half pipe while the solid waste pump discharges through a two inch pipe. 2 Inch pipe material noted.

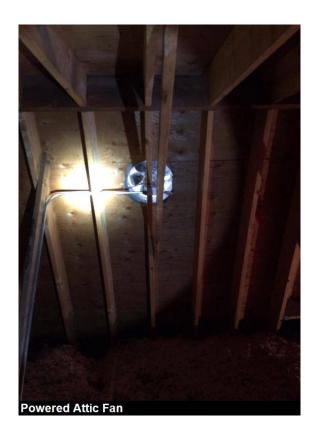
B. Venting of Attic (mechanical and passive)

The powered attic fan was not tested, either due to inaccessibility, colder temperatures, or a non-adjustable temperature control.
